DEPARTMENT OF TRANSPORTATION**DIVISION OF ENGINEERING SERVICES**

Quality Assurance and Source Inspection

Contract #: 04-0120F4Cty: SF/ALA Rte: 80 PM: 13.2/13.9File #: 1.28**WELDING INSPECTION REPORT****Resident Engineer:** Casey, William**Address:** 333 Burma Road**City:** Oakland, CA 94607**Report No:** WIR-028277**Date Inspected:** 27-Aug-2012**Project Name:** SAS Superstructure**OSM Arrival Time:** 700**Prime Contractor:** American Bridge/Fluor Enterprises, a JV**OSM Departure Time:** 1930**Contractor:** American Bridge/Fluor Enterprises, a JV**Location:** Job Site

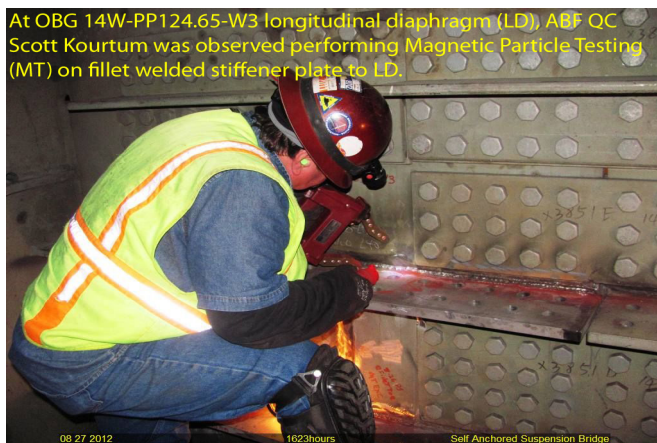
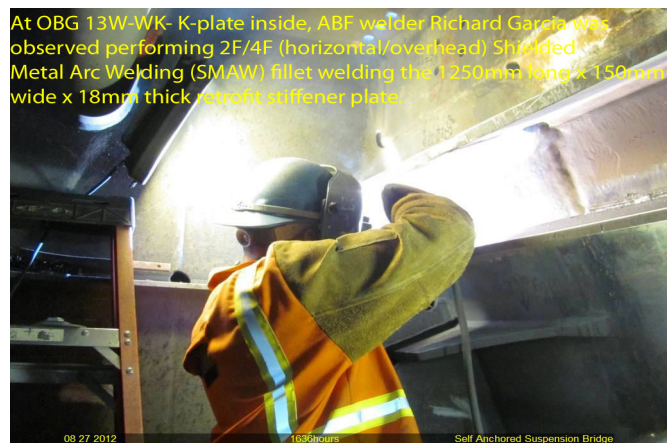
1. 13W-PP124.5-W2.8 BW1 - web splice butt joint weld cover QA verified.
2. 13W-PP124.5-W2.8 BF1 - flange splice butt joint weld cover QA verified.
3. 13W-PP124.0-W2.8 BF1 - web splice butt joint weld cover QA verified.
4. 13W-PP122.0-W2.8 BF1 - web splice butt joint weld cover QA verified.
5. 13W-PP123.6-@950 - drop-in top deck plate splice butt joint weld cover QA verified.
6. 13W-W2.2-@5180 - drop-in top deck plate splice butt joint weld cover QA verified.
7. 13W-PP124.65-W3 – longitudinal diaphragm stiffener fillet weld joints QA verified.
8. 13W-PP124.65-W3 – four lifting lug bracket remnants “pyramid” slope ratio and smooth grinding

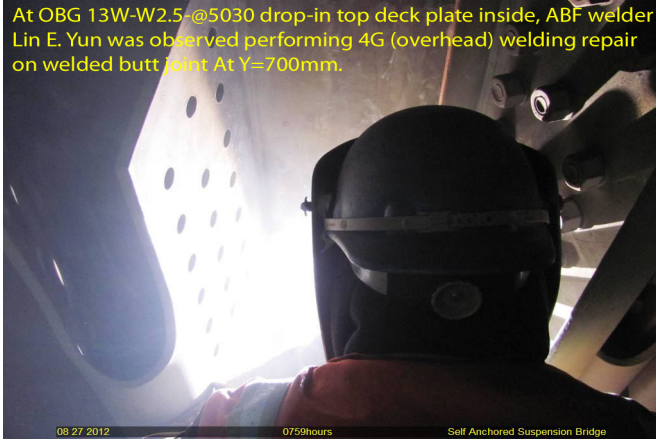
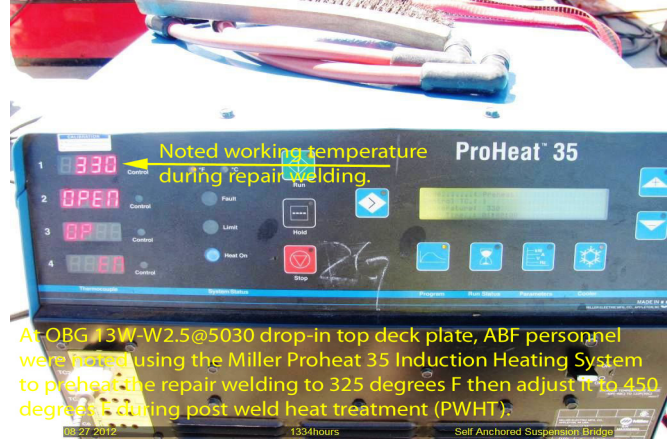
At OBG 13W-W2.5@5030 drop-in top deck plate inside, ABF welder Lin E. Yun was observed performing 4G (overhead) welding repair on welded butt joint At Y=700mm.
